“Holden Isuzu, Rodeo, Colorado, D-max Remote Key - Worn out button replacement procedure” was prepared by Polmex , the West Australian innovative Engineering Company, specializing in design and manufacture of special purpose Silicone products. Supplying to the market Silicone Replacement Buttons for worn remote keys of various car makes and models. Holden, Land Rover, Mitsubishi, Nissan, Hyundai, Toyota, Ford, Commodore, Mazda, BMW and more ...

You are replacing 2 worn buttons in **Holden Rodeo, Colorado, Isuzu** key with Silicone Repair Pad from POLMEX.

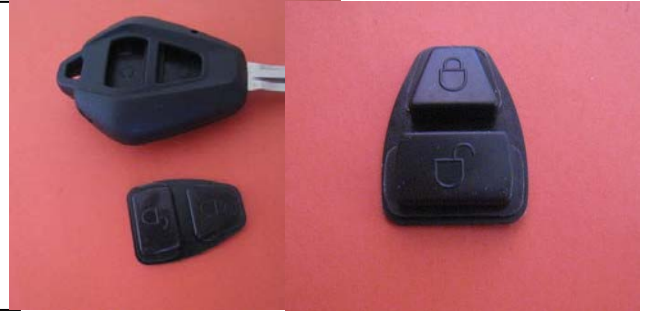
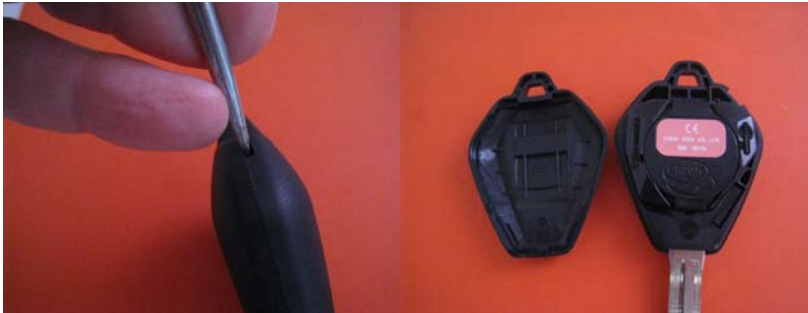
Use flat screwdriver to prise remote open on the split line. You will end up with bottom part of shell and top shell with buttons and electronic board.

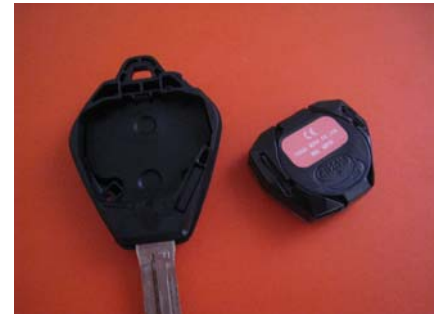
Remove electronic component from top shell and uncover thin rubber spacer.

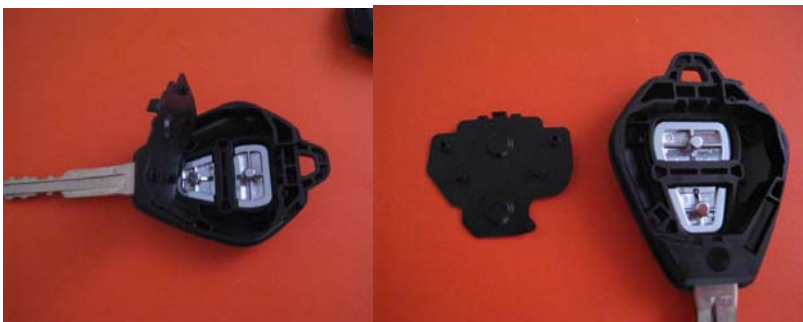
Remove rubber spacer and existing worn buttons. With our flexible Silicone Pad, rubber spacer will not be need it.

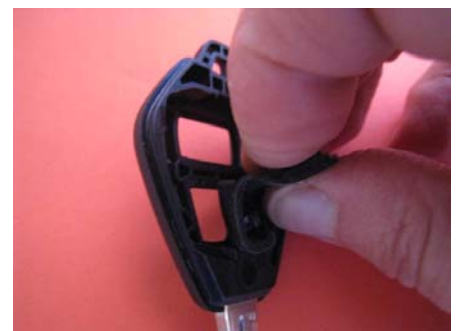
Start installing new pad by pushing one end of it under cut-out in plastic shell, till it stays in place

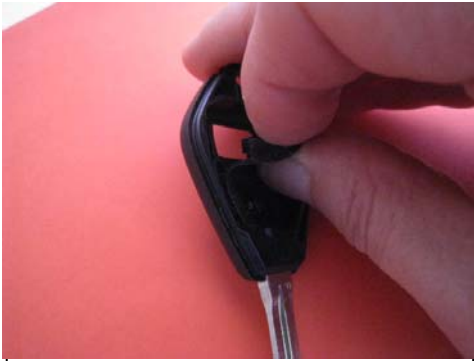
Continue the same process for second cut-out till last section of the new replacement pad engages with plastic cover.

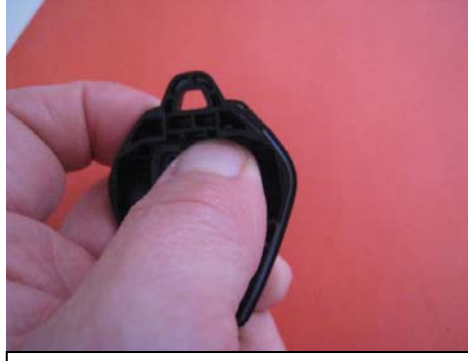
Push buttons slightly thru cut-outs till they look levelled with surface of the shell. Once Buttons pad is installed and buttons sit correctly, you can put your remote key together in reverse order.

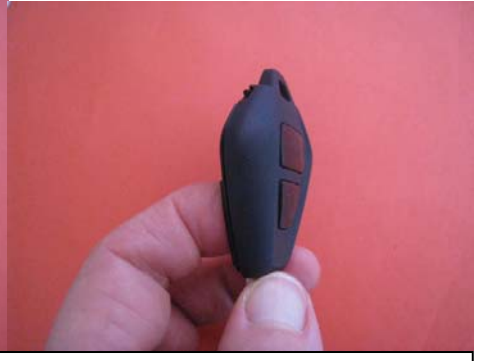
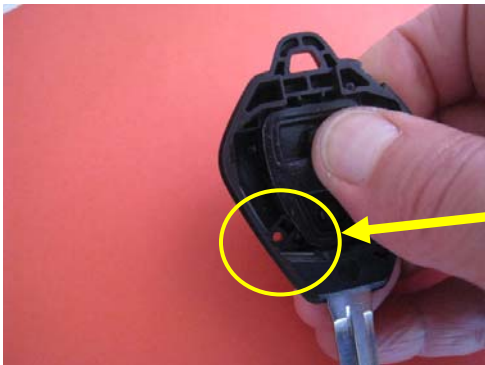
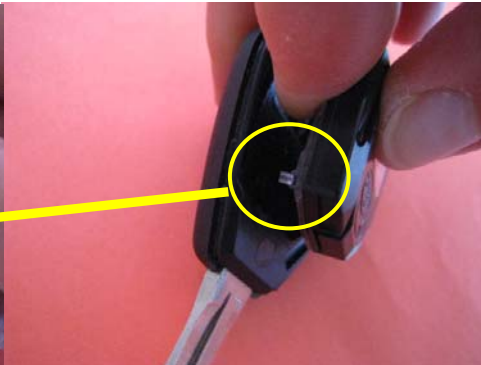
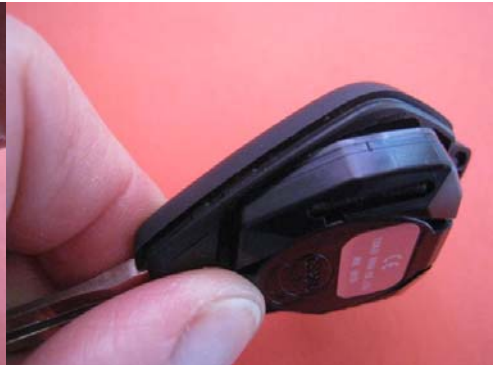
Place electronic component on the top of the Silicone Pad taking care of the little light that should gently fit in the hole provided (*as highlighted above*).

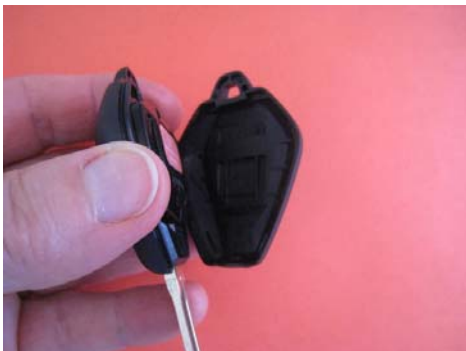
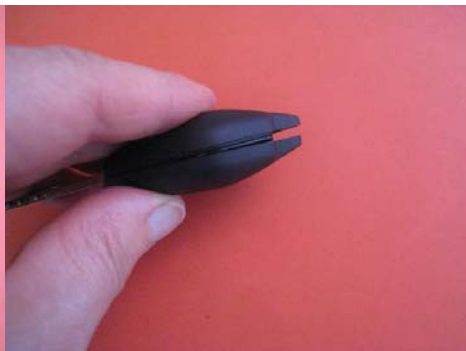
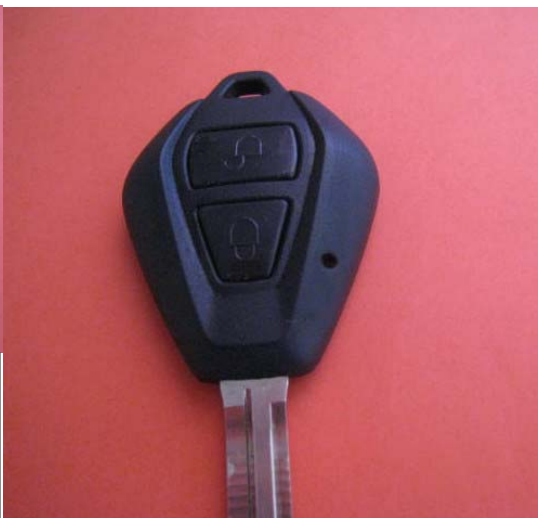
Place bottom part of shell over the top part and close it till it clicks. Your refurbished remote is ready for use without need for re-programming.
