This procedure for “*Autowatch 446RLi, 457RLi, 458RL, 650, 695 CAN alarm immobiliser systems remote key Buttons Replacement*” was prepared by Polmex – Western Australian manufacturer of Silicone Button Replacements for remote key controls of various car makes and models: Land Rover, Range Rover, Toyota, Mitsubishi, Kia, Holden, Commodore, Ford, Hyundai, BMW and more...

You are replacing worn buttons cover in 4 Button Autowatch remote fob with Silicone Repair Pad from POLMEX.

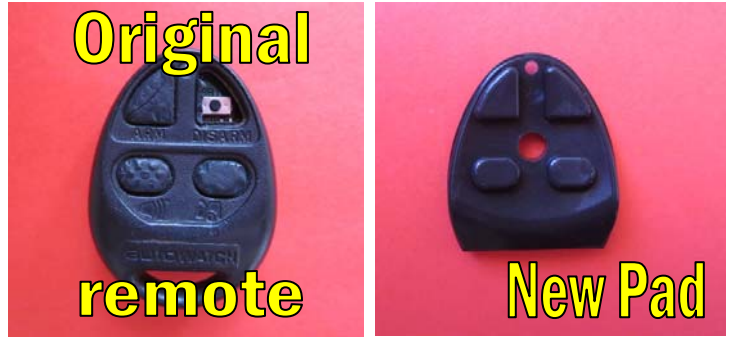
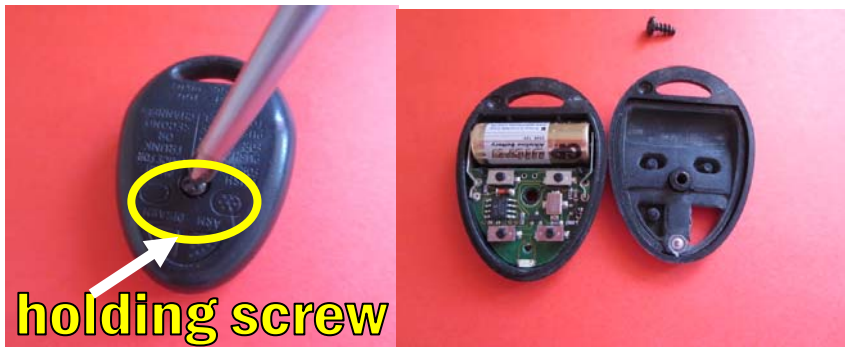
Unscrew a small screw at the back of plastic shell. Open remote and separate top hard shell part with button key pad and part with electronic board and battery. Part with electronics will remain untouched and you will be only working with half of the shell consisting of key buttons.

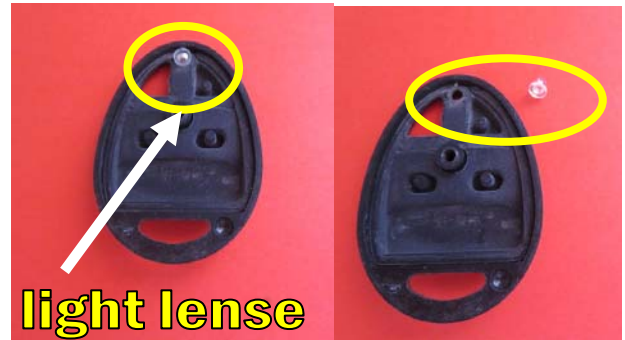
Next you will be separating old button pad from plastic shell. Please note small light lens located at the top of the button pad. You will have to remove it first before detaching old rubber pad.

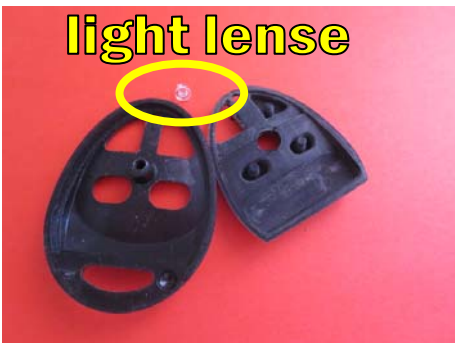
You can lift light lens using small flat screwdriver or just a finger nail. Try not to misplace it as it will be fitted in exactly the same spot once new pad is installed.

Once lense is removed, you can push old key pad out from plastic shell using your thumb.

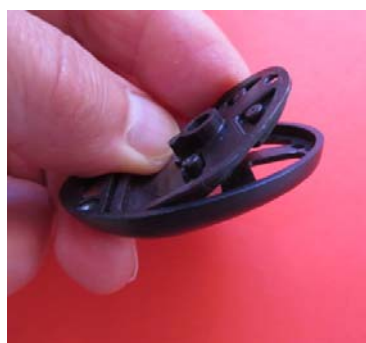
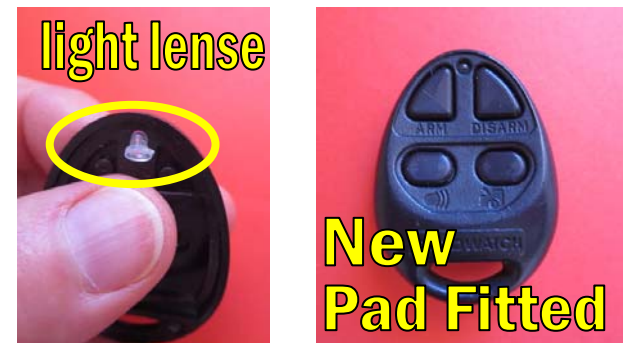
Next you will be installing NEW Silicone Pad.

Push key buttons of the new pad thru key button holes in plastic shell. Once all buttons and whole pad are correctly positioned, you need to press light lens thru small hole at the top of the new pad, till it engages with hard shell.

Next you will re-assemble you remote by placing key button part of shell over part containing electronics. Press both parts of shell till they close and screw it together. Your remote is now ready to use again. No re programming is needed.
