This procedure for *“Remote key Button Replacement for Holden Barina, Vectra, Omega...”* was prepared by Polmex – Western Australian manufacturer of Silicone Button Replacements for remote key controls of various car makes and models: Land Rover, Range Rover, Toyota, Mitsubishi, Kia, Holden, Commodore, Ford, Hyundai, BMW ...and more

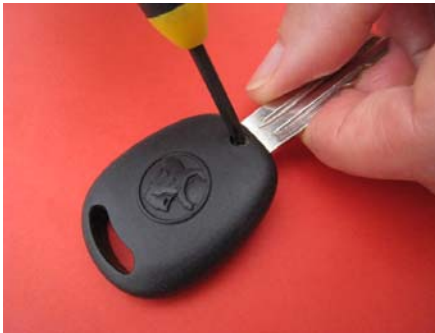
Unscrew holding screw located at the back of your remote key.

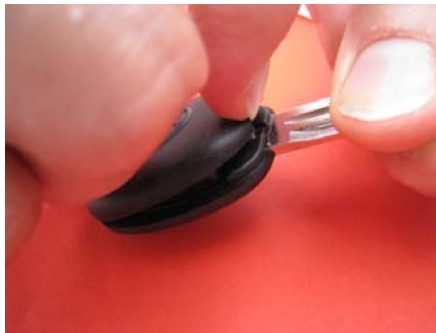
Separate back part of the cover from the key and pull your remote apart. If your buttons are already missing you may still have spring metal plate attached to the inside of remote.

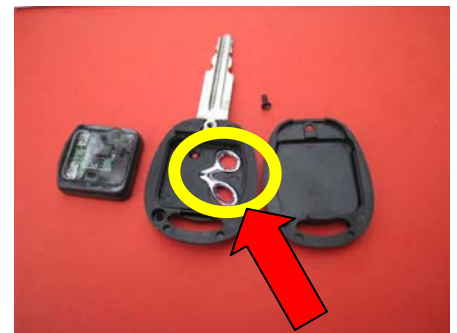
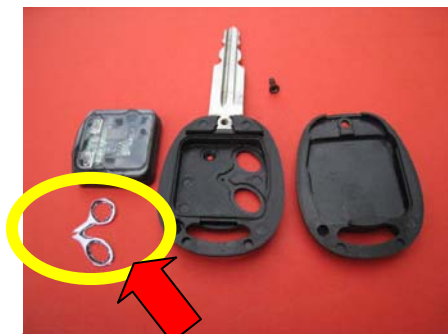
Spring metal plate needs to be discarded. It will not be re-used.

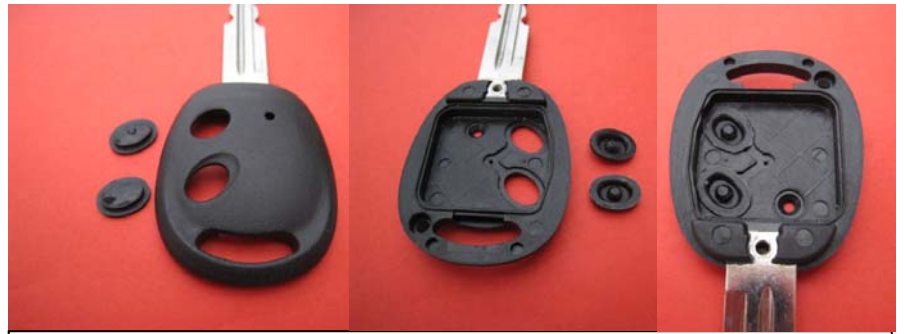
Silicone buttons will be fitted from inside of remote. Simply press fit silicone buttons in. For easier thumb recognition you can dedicate button with the tactile dot to locking function.

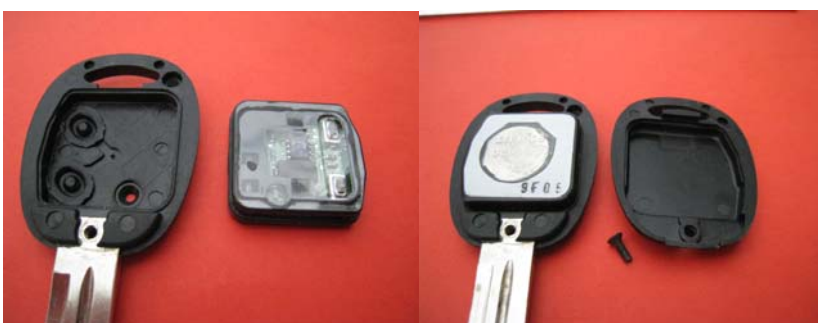
Once your silicone buttons are fitted in, place electronic board back in remote, cover it with bottom part of the shell and screw it together. **No reprogramming is need it** as remote will work straight away.

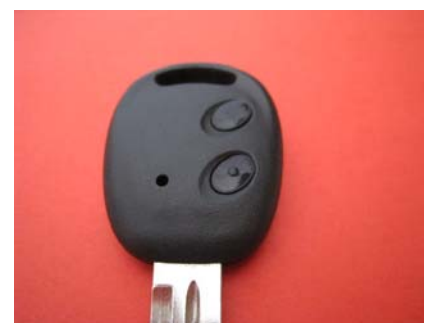
Your remote with fitted in silicone repair buttons will look like the one above.
