This procedure for “*Hyundai: Terracan, Amica, Atos, Atoz remote key – Worn out button replacement procedure*” was prepared by Polmex – Western Australian manufacturer of Silicone Button Replacements for remote key controls of various car makes and models: Land Rover, Range Rover, Toyota, Mitsubishi, Kia, Holden, Commodore, Ford, Hyundai, BMW ...and more

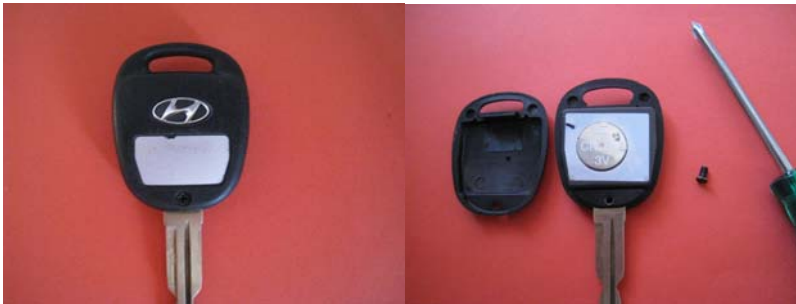
Unscrew holding screw located at the back of your remote key.

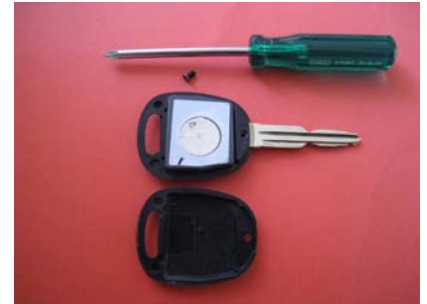
Separate back part of the cover from the key.

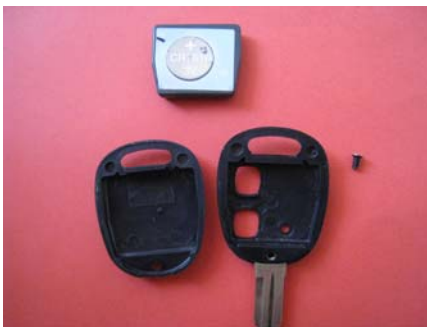
Pull your remote apart as shown on the picture above.

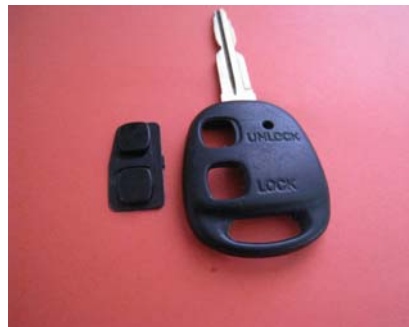
Silicone buttons will be fitted from inside of the remote. Simply press fit silicone buttons in.

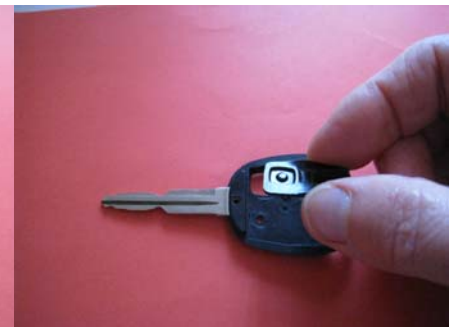
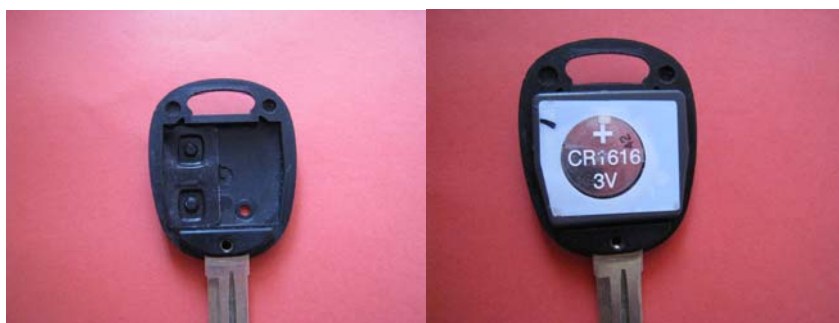
Once your silicone buttons are fitted in, place electronic board back in remote, cover it with bottom part of the shell and screw it together. **No reprogramming is need it** as remote will work straight away.

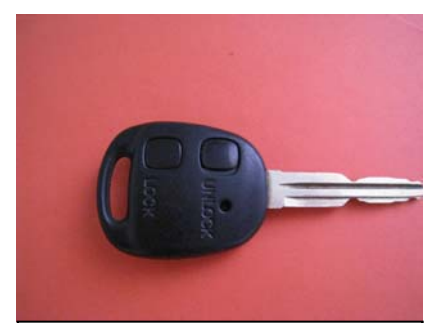
Your remote with fitted in silicone repair buttons will look like the one above.
