This procedure for “*Hyundai i10,i20, i30, i35,i40 Genesis, Tuscon, Accent Active, SantaFe replacement button pad instructions*’ prepared by Polmex – Western Australian manufacturer of Silicone Button Replacements for remote key controls of various car makes and models: Land Rover, Range Rover,Toyota, Mitsubishi, Kia, Holden, Commodore, Ford, Hyundai, BMW, Nissan, Hyundai and more

You are replacing worn buttons cover in Hyundai flip key with Silicone Repair Pad from POLMEX.

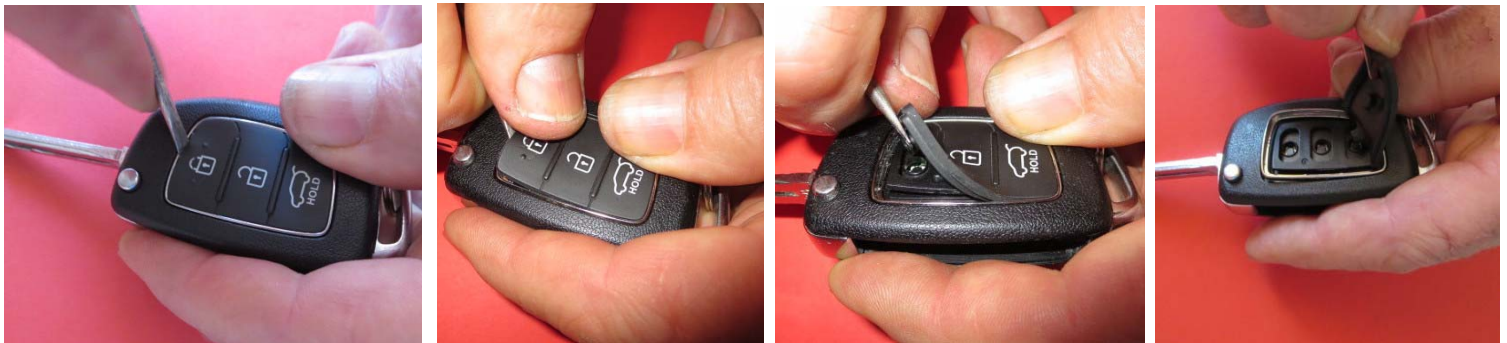
Do Not open remote. Gently remove an old rubber pad from your remote using flat screw driver.

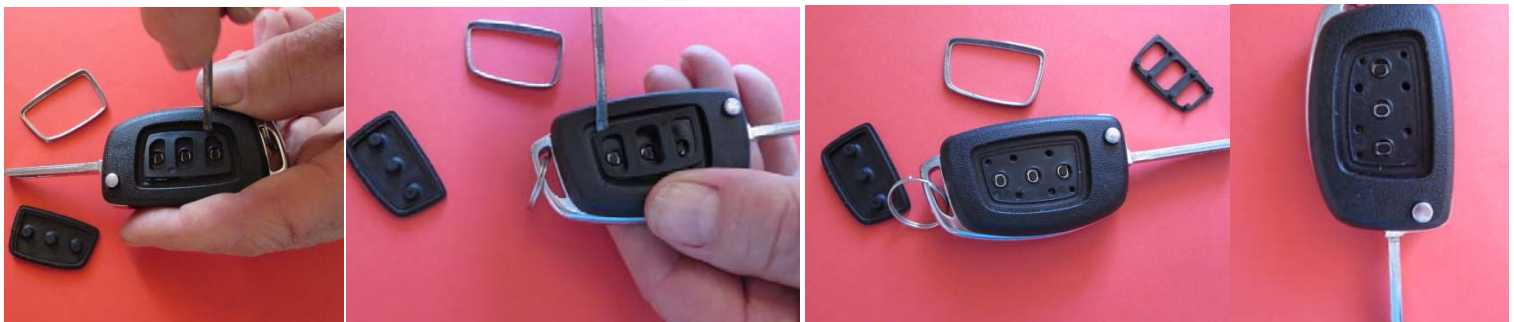
Next you need to remove plastic stiffener still attached to your remote. Use small flat screwdriver to lift it up and detach from remote. It will not be used as new Silicon buttons does not need extra support.

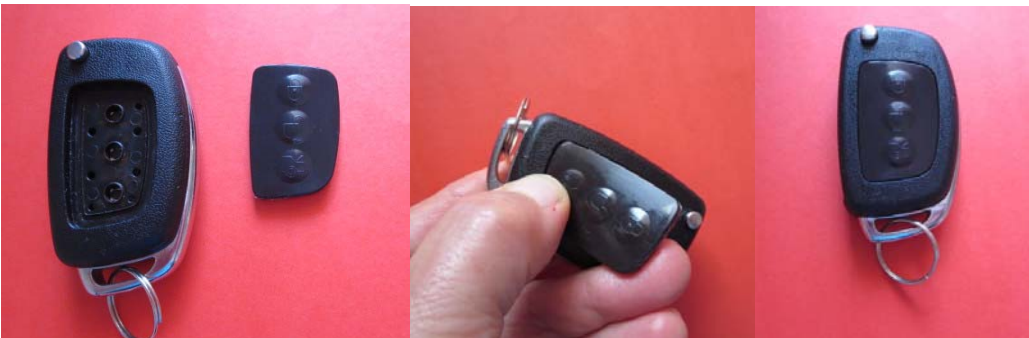
Place a new silicone pad over top part of your remote. Use rolling motion when positioning pad in grooves and press firmly till pad “engages“ with hard shell all around edges. **DO NOT USE** any lubricants or detergents for cleaning grooves as it will affect firm seating of a pad.
No re-programming is required.
