This procedure for “*Hyundai i10, i20, i30, i35 replacement button pad instructions – part number CE: 0682*” prepared by Polmex – Western Australian manufacturer of Silicone Button Replacements for remote key controls of various car makes and models: Land Rover, Range Rover, Toyota, Mitsubishi, Kia, Holden, Commodore, Ford, Hyundai, BMW, Nissan, Hyundai and more

You are replacing worn buttons cover in Hyundai i10, i20, i30, i35 flip key with Silicone Repair Pad from POLMEX.

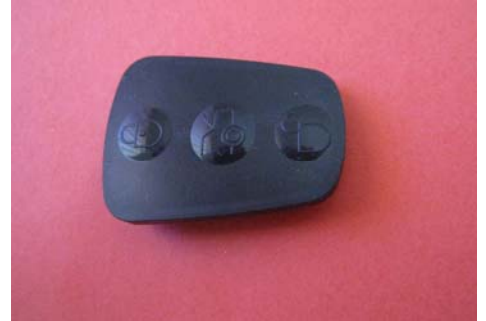
Our pads are made form high purity LSR Silicone and will not: deform, change shape, become brittle and break unlike original cover. It is a great fix at a fraction of the price of new remote and re-programming.

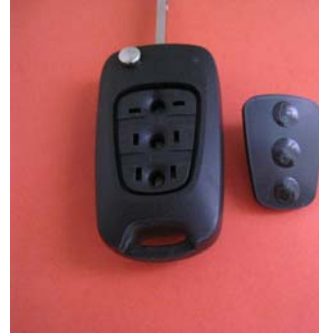
Gently remove an old rubber pad from your remote. Your remote should look like the one in the picture on the side, free of any old rubber pieces and dirt.

You may use small flat screwdriver or toothpick to remove any remnants from grooves. **DO NOT USE** any sharp objects.

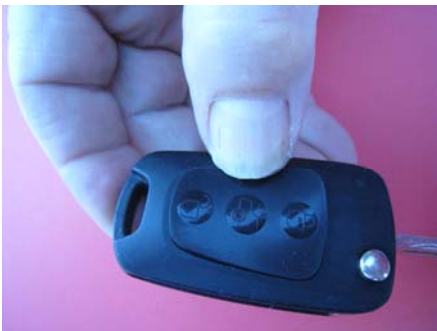
Place a new silicone pad over top part of your remote. Use rolling motion when positioning pad in grooves and press firmly till pad “engages“ with hard shell all around edges and in the middle. If the pad is not sitting in level with the shell you can use finger nail to push it deeper in the groove.

DO NOT USE any lubricants or detergents for cleaning grooves as it will affect firm seating of a pad.

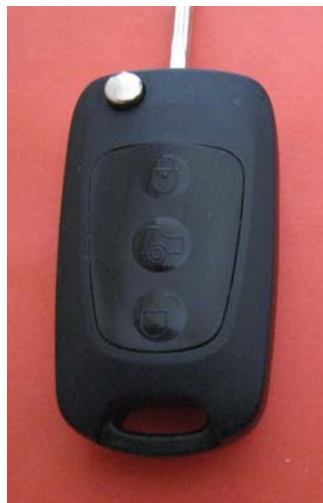
No programming is need it as remote is ready to work again.
