This procedure for “MG 25-45 ZR TF ZS MGB Rover ZR ZT Montego remote key – Worn out button replacement procedure” was prepared by Polmex, Western Australian innovative Engineering Company, specializing in design and manufacture of special purpose Silicone products. Supplying to the market Silicone Buttons for worn out remote keys of various makes and models: Hyundai, Holden, Commodore, Ford, Mitsubishi, Nissan, Rover, Land Rover, Peugeot, BMW, Jeep, Mazda , Rover, Kia, Jeep, Mercedes and more...

Button Replacement Procedure

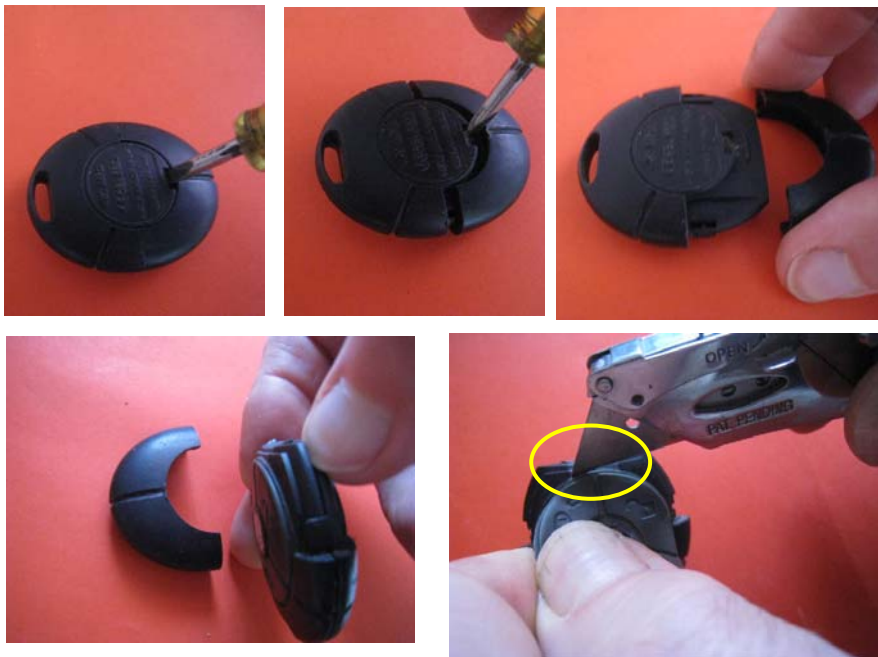
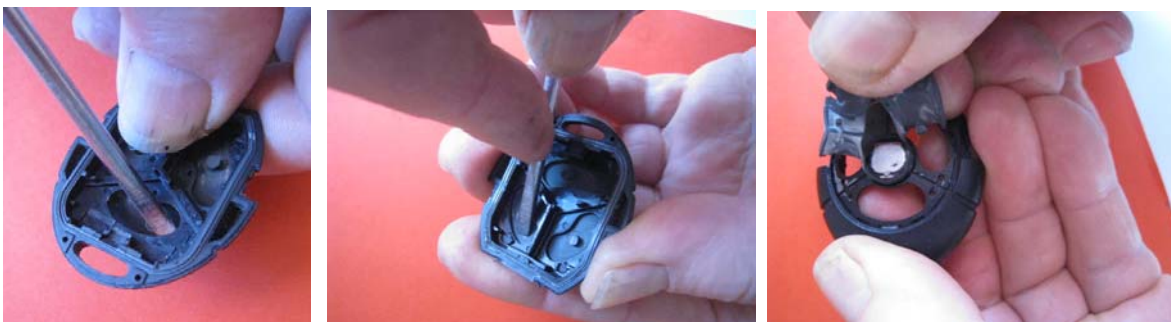
1. Place flat screwdriver in the slot located on the back of the remote. Twist screwdriver to detach plastic semi circle shaped, clip on part of the shell .
2. Using your fingernail split two parts of the remote and remove electronic board from the shell.
3. Before you start removing old worn key buttons pad you will need to cut it with the Stanley knife around the top soft part of the shell. Next, using flat screwdriver you will press on old buttons from inside of the remote and push worn pad out from the shell.

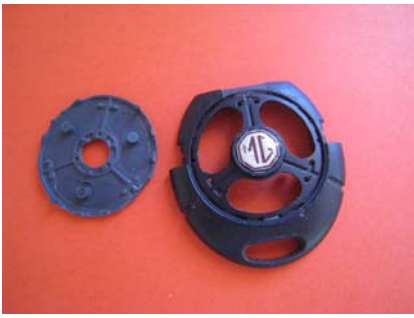
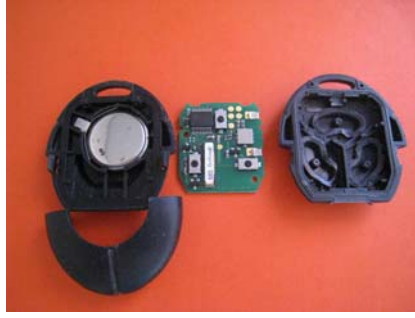
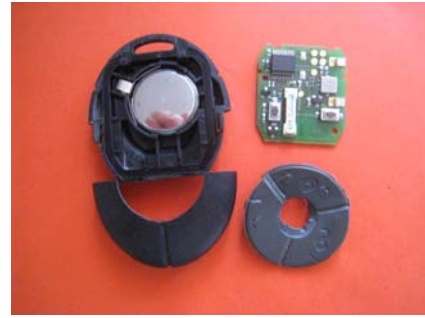
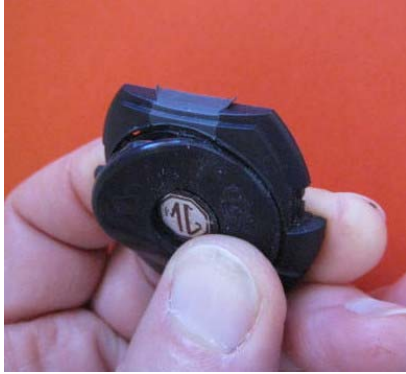
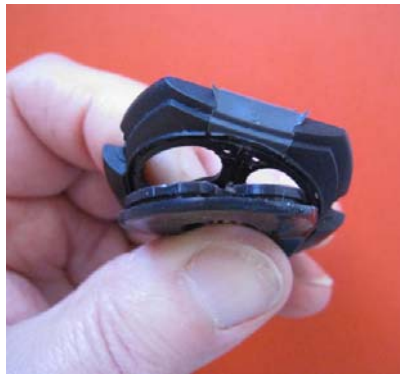
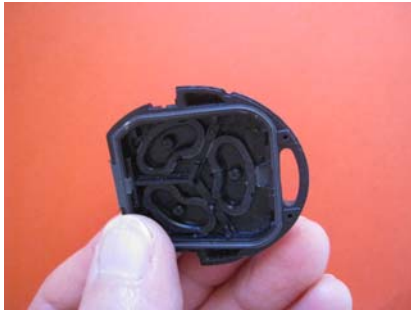
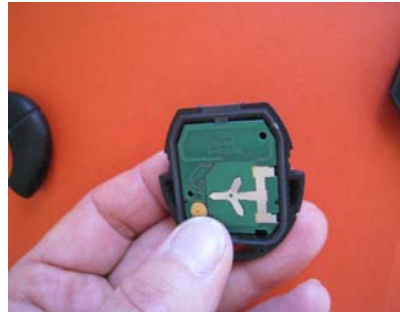
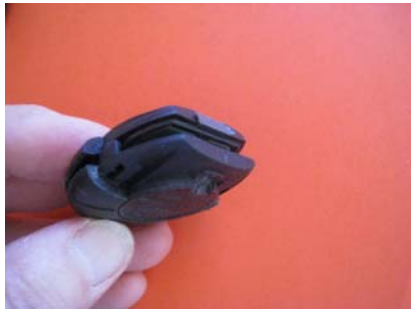
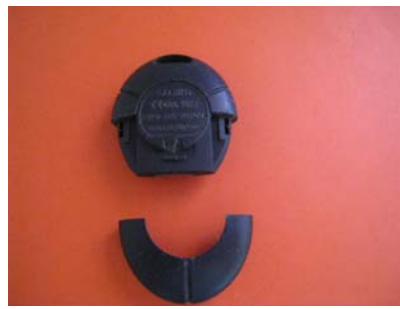
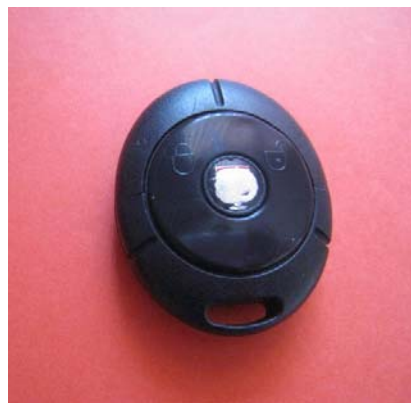
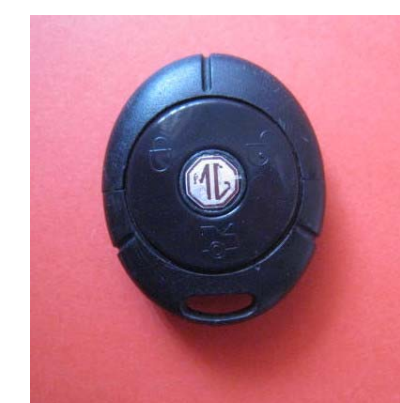
4. Next you will be installing your new pad in by pressing buttons inside matching holes and manipulating it into position till each button comes thru its hole.

5. Once buttons pad is fitted in you will place electronic board over it. Next you will place bottom part of the shell over the top part and press it till it closes firmly

6. Last you will slide semi circular plastic part over closed parts of the shell to lock all components in.
