This procedure for *“Remote key Button Replacement for Mini Cooper, BMW.”* was prepared by Polmex – Western Australian manufacturer of Silicone Button Replacements for remote key controls of various car makes and models: Land Rover, Range Rover, Toyota, Mitsubishi, Kia, Holden, Commodore, Ford, Hyundai, BMW, ...and more

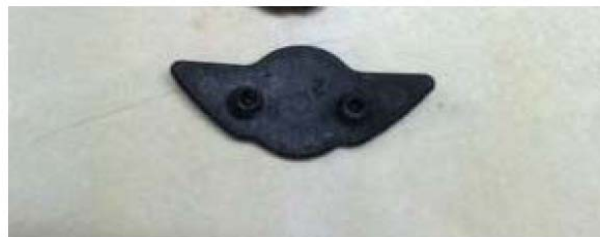
If wing button in your remote is **mounted on rear plastic piece** as in this picture below:

and is not part of rubber overlay suitable for **cutting out** than it will be too narrow and will not fit.

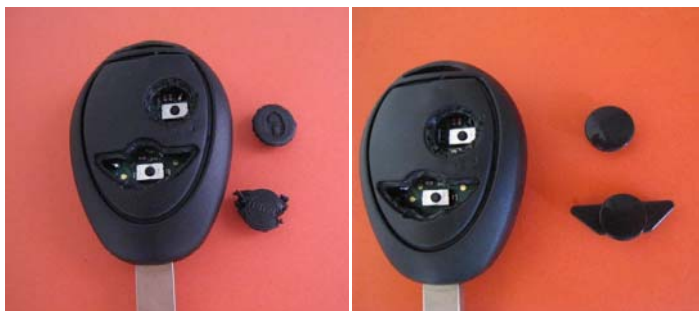
Please note that our buttons will only suit your remote if top rubber layer is still well attached to plastic shell (as shown in our picture gallery). If top rubber layer in your remote is coming off plastic shell than our buttons will not fit well and fitting is not recommended.

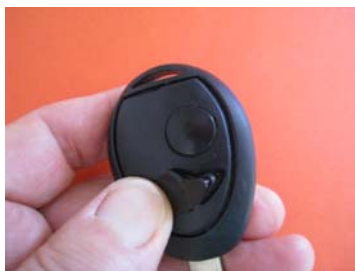
This repair set consists of 2 differently shaped buttons: lock and unlock.

We recommend press fitting of your new buttons from outside of remote matching buttons per function and cut out shape. It is possible to open remote and position buttons from inside of the shell but this is more complicated method.

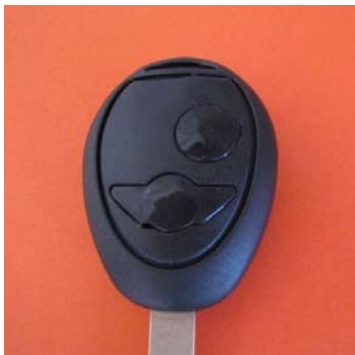
Once your silicone buttons are fitted in remote will work straight away.

No reprogramming is need it.
